LOSS LESSONS

MACHINERY BREAKDOWN ON A WATER TURBINE

REPORT PUBLISHED BY
ALLIANZ RISK CONSULTING

Hydropower Station

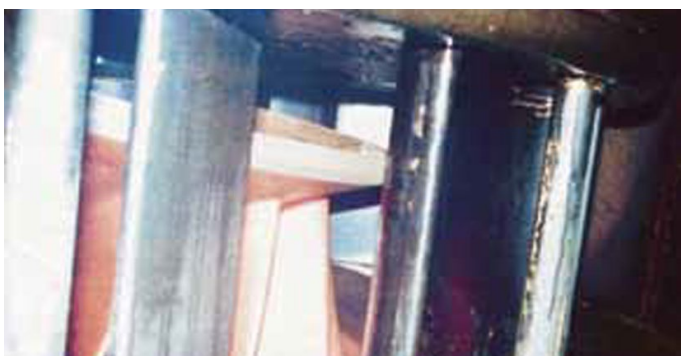
The power station is operated with a remote control system, without local human attendance. During a routine remote checking, the operator noted that the generator was not delivering any power but was running in motor mode. After isolation and water drainage, the inspection of the internal parts showed that the wheel was on free rotation on the shaft and had jammed in the inlet guide vanes and the exhaust bushing.

- Rupture of connecting bolts between the wheel and the shaft
- Metal rubbing on rotating parts
- Metal rubbing on stationary parts
- Journal bearing damage

Water pressure applied an axial load on the shaft line that is partially balanced by holes drilled into the hub of the wheel. These holes also allow the drainage of the bearing lubricating water. Loss was caused by a faulty design of the balancing holes. The flushing of the bearing was not correct (too low flow), the bearing overheated and clearance increased out of margins. Consequently, high vibrations and dynamic loads were developed by the turbine, bolts were over strained and broken, then the wheel dropped inside the stator.

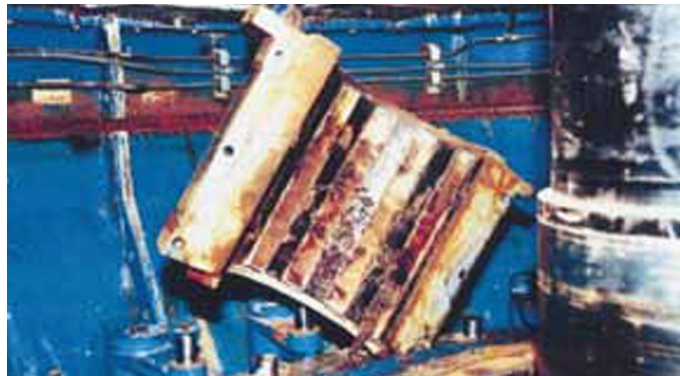
This type of water turbine is traditionally assembled on site without prior shop test. Commissioning and provisional acceptance were delivered without any mechanical running tests. The operating conditions for the mechanical parameters were not checked and not logged (bearing temperature, bearing water pressure, vibration level, bearing water flow). Tuning and adjustments (clearances, sizing of wheel balance holes) could not be carried out due to unexisting test results. Basic loss prevention methods and protective devices would possibly have avoided or reduced the damages.

Commissioning and start up phases would possibly be formalized with a certificate of completion. Tests and controls should be included in the acceptance procedure and these tests could be carried out in presence of all the parties involved in the works (client, engineering, contractor, manufacturer). It is a common interest to detect during erection abnormal operating conditions and it is easier to carry out changes before the end of works.

On line supervision of turbine with temperature and vibration monitors would allow the setting of a preventive maintenance and a reduction of the consequences of any failures or breakdown (cost and duration). Temperature and vibration are reliable indicators of mechanical condition for rotating equipment.
