LOSS LESSONS

MACHINERY BREAKDOWN ON A WATER TURBINE

REPORT PUBLISHED BY
ALLIANZ RISK CONSULTING

Hydropower Station

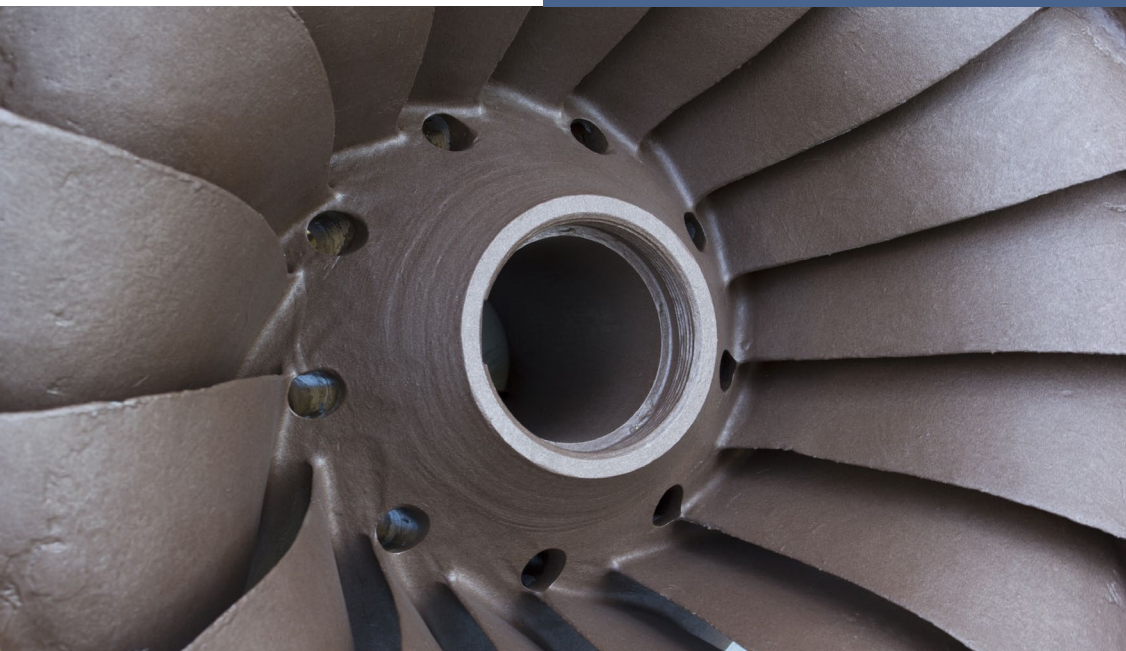
The power station is operated with a remote control system, without local human attendance. During a routine remote checking, the operator noted that the generator was not delivering any power but was running in motor mode. After isolation and water drainage, the inspection of the internal parts showed that the wheel was on free rotation on the shaft and had jammed in the inlet guide vanes and the exhaust bushing.

- Rupture of connecting bolts between the wheel and the shaft
- Metal rubbing on rotating parts
- Metal rubbing on stationary parts
- Journal bearing damage

Water pressure applied an axial load on the shaft line that is partially balanced by holes drilled into the hub of the wheel. These holes also allow the drainage of the bearing lubricating water. Loss was caused by a faulty design of the balancing holes. The flushing of the bearing was not correct (too low flow), the bearing overheated and clearance increased out of margins. Consequently, high vibrations and dynamic loads were developed by the turbine, bolts were over strained and broken, then the wheel dropped inside the stator.

Commissioning and start up phases would possibly be formalized with a certificate of completion. Tests and controls should be included in the acceptance procedure and these tests could be carried out in presence of all the parties involved in the works (client, engineering, contractor, manufacturer). It is a common interest to detect during erection abnormal operating conditions and it is easier to carry out changes before the end of works.

On line supervision of turbine with temperature and vibration monitors would allow the setting of a preventive maintenance and a reduction of the consequences of any failures or breakdown (cost and duration). Temperature and vibration are reliable indicators of mechanical condition for rotating equipment.
