# **TECH TALK**

# BATTERY ENERGY STORAGE SYSTEMS (BESS) USING LI-ION BATTERIES

**ALLIANZ RISK CONSULTING**

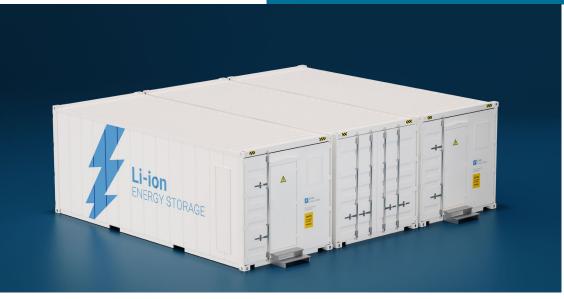
Battery energy storage system made of shipping containers

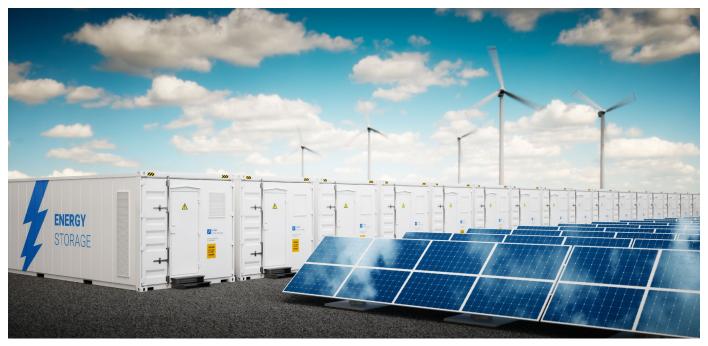
Renewable energy power plants - photovoltaics, wind turbine farm and battery container.
